**Flood Control Project Maintenance
Levee Inspections**

Maintenance Issue Types Only, Levee Inspection Report By Mile - Fall 2019

Tehama County Flood Control and Water Conservation District

Waterway	Bank	Unit Miles	Inspection Start/End	Inspector
Unit No. 01 Deer Creek	Left	4.22	10/30/2019 10/30/2019	Makar Sokol

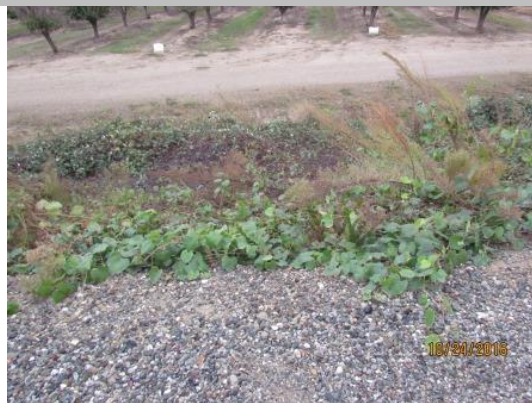
Photo 1 of 1 : FA_2019_NA0019_81_39_20190822_00019.jpg

LM Start	3.40	Rating **	M	Issue No.	39
LM End	3.44	Issue Type +	Ma	Location *	LS
Category	Earthen Levee			GPS Latitude/Longitude	
				Start	End
Item	Vegetation			40.056546 °	40.055906 °
				-122.133530 °	-122.133294 °
DWR ID	DWR_NA0019_04_f_2016_39				
Comment Code					
V2 : Remove the wild growth other than native grasses from the levee slopes.					
Inspector Comment

View of the blackberries along the landside slope blocking visibility and access.

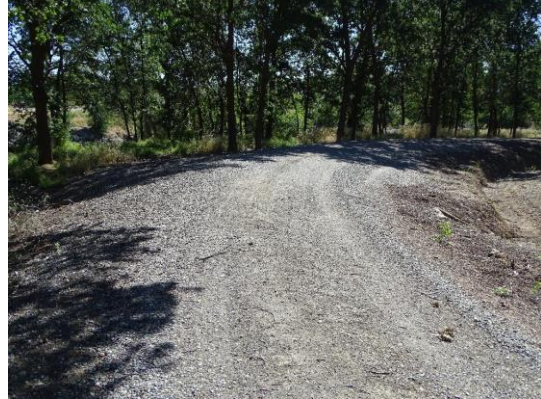
Photo 1 of 3 : UCIP_FA_2019_54066_79377.jpg

LM Start	0.11	Rating **	M	Issue No.	20
LM End	0.11	Issue Type +	Ma	Location *	
Category	Supplemental			GPS Latitude/Longitude	
				Start	End
Item	DRAFT DWR UCIP LMA Responsibility			40.051702 °	40.051702 °
				-122.189922 °	-122.189922 °
DWR ID	20799				
Comment Code					
Inspector Comment					
DS_ID:20799					
FS_ID:54066					
EP_NO: N/A					
Repair Type: Non-Urgent					
Crossing Status: Found					
UCIP Comments: 05/28/2019 Debris at the outlet needs to be cleared for proper flap gate operation. (O.Yakimov - DWR UCIP)					
FIELD_STRUCT_DESC: 24-inch corrugated metal drainage pipe through the levee, 5.4 feet below the crown. Flap gate on the waterside (WS) end. Concrete U-shaped headwalls on the WS and landside (LS) ends. [Additional Reference(s): DWR Levee Log, 1992. USACE Sacramento O&M Manual 510, April 1963, (HLM 0.11) Drawing No. 50-4-3622].					
FS Date: 5/28/2019 1:31:26 PM

View of levee crown at crossing

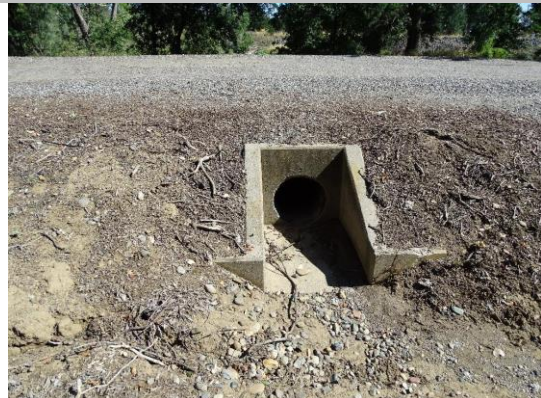
Photo 2 of 3 : UCIP_FA_2019_54066_79378.jpg

View of headwall at LS toe

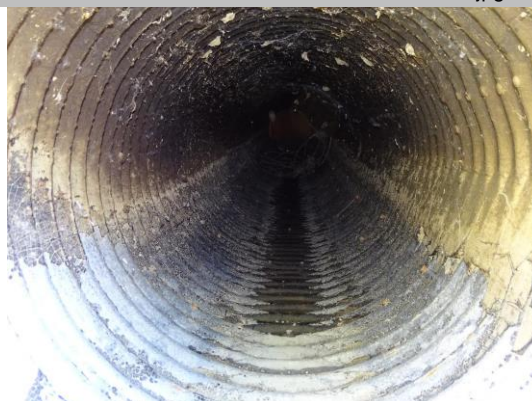
Photo 3 of 3 : UCIP_FA_2019_54066_79379.jpg

LM Start	0.11	Rating **	M	Issue No.	20 (cont)
LM End	0.11	Issue Type +	Ma	Location *	
Category	Supplemental			GPS Latitude/Longitude	
				Start	End
Item	DRAFT DWR UCIP LMA Responsibility			40.051702 °	40.051702 °
				-122.189922 °	-122.189922 °
DWR ID	20799				
Comment Code					
Inspector Comment					
DS_ID:20799 FS_ID:54066 EP_NO: N/A Repair Type: Non-Urgent Crossing Status: Found UCIP Comments: 05/28/2019 Debris at the outlet needs to be cleared for proper flap gate operation. (O.Yakimov - DWR UCIP) FIELD_STRUCT_DESC: 24-inch corrugated metal drainage pipe through the levee, 5.4 feet below the crown. Flap gate on the waterside (WS) end. Concrete U-shaped headwalls on the WS and landside (LS) ends. [Additional Reference(s): DWR Levee Log, 1992. USACE Sacramento O&M Manual 510, April 1963, (HLM 0.11) Drawing No. 50-4-3622]. FS Date: 5/28/2019 1:31:26 PM

Inside of pipe looking from LS inlet

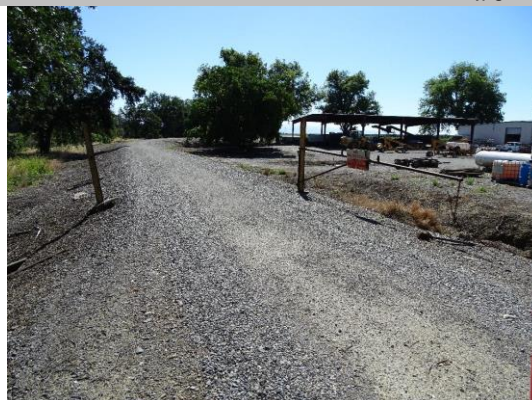
Photo 1 of 3 : UCIP_FA_2019_54069_79394.jpg

Comment Code					
Inspector Comment					
DS_ID:20801 FS_ID:54069 EP_NO: N/A Repair Type: Non-Urgent Crossing Status: Found UCIP Comments: 05/28/2019 No issues recorded during inspection. (O.Yakimov - DWR UCIP) Debris inside pipe at WS toe needs to be removed as it may prevent proper operation of the flapgate. FIELD_STRUCT_DESC: 24-inch corrugated metal drainage pipe through the levee, 5.2 feet below the crown. Flap gate on the waterside (WS) end. Concrete U-shaped headwalls on the WS and landside (LS) ends. [Additional Reference(s): DWR Levee Log, 1992. USACE Sacramento O&M Manual 510, April 1963, (HLM 0.51) Drawing No. 50-4-3622]. FS Date: 5/28/2019

View of levee crown at the crossing

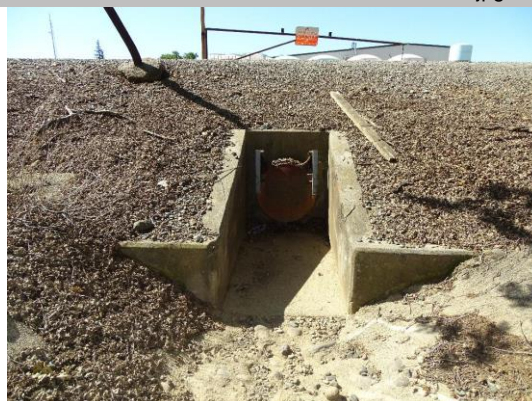
Photo 2 of 3 : UCIP_FA_2019_54069_79395.jpg

Comment Code						
Inspector Comment						
DS_ID:20801 FS_ID:54069 EP_NO: N/A Repair Type: Non-Urgent Crossing Status: Found UCIP Comments: 05/28/2019 No issues recorded during inspection. (O.Yakimov - DWR UCIP)Debris inside pipe at WS toe needs to be removed as it may prevent proper operation of the flapgate. FIELD_STRUCT_DESC: 24-inch corrugated metal drainage pipe through the levee, 5.2 feet below the crown. Flap gate on the waterside (WS) end. Concrete U-shaped headwalls on the WS and landside (LS) ends. [Additional Reference(s): DWR Levee Log, 1992. USACE Sacramento O&M Manual 510, April 1963, (HLM 0.51) Drawing No. 50-4-3622]. FS Date: 5/28/2019

Headwall at WS toe

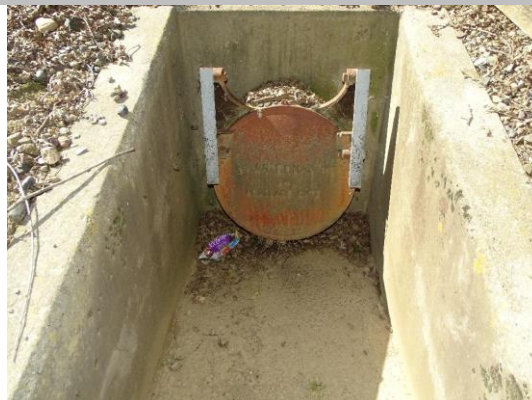
Photo 3 of 3 : UCIP_FA_2019_54069_79396.jpg

LM Start	0.50	Rating **	M	Issue No.	21 (cont)
LM End	0.50	Issue Type +	Ma	Location *

Flap gate at WS toe
